FEEDWATER CAPACITY UPGRADE

INTRODUCTION

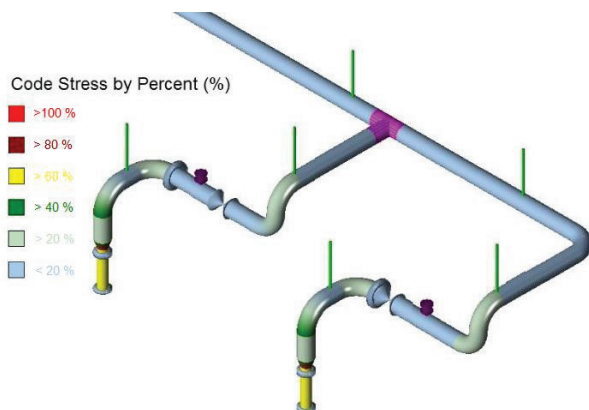
FIGURE 2: STATIC STRESS MODEL AT THE PUMPS.

The static analysis results also indicated that the piping systems were generally acceptable for steady state operation, this can

been interpreted from Figure 2, on the other hand better thermal expansion control was also needed. During the modal analysis these systems were found to be dynamically unstable.

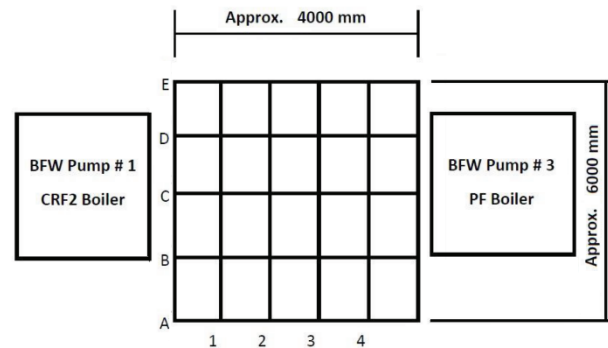
FIGURE 3: STATIC STRESS MODEL AT THE PUMPS.

During normal operation of the feed water system, some vibration characteristics were identified (or assumed) to be emanating from the floor structure between the CRF2 and PF boiler feed pumps. In discussion with the client's condition monitoring technicians, a so-called "weak point" was identified at this location. Site inspection indicated that this point displayed greater vibration characteristics than the surrounding areas. Vibration measurements were recorded along a grid pattern in this area, to establish if any possible dynamic structure instability contributed to the adverse vibration conditions experienced. Figure 3 below, gives indication to size of the area measured.

During this exercise, no abnormal vibration conditions were evident, resulting in measured data representing a steady state of operation. However, as the systems were operating in a steady state during the test and it was expected that amplitudes would increase during any dynamic events.

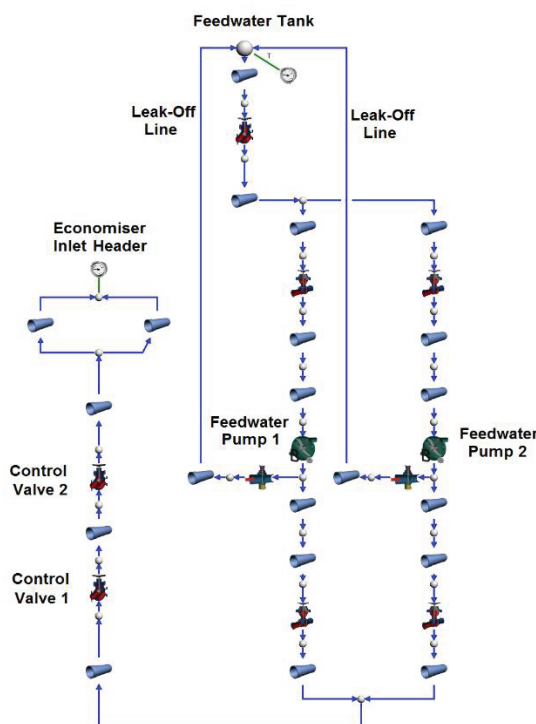
FIGURE 4: L SIMULATION MODEL FOR THERMAL-HYDRAULIC ANALYSIS.

With the operating temperature at 152 °C, equating to a saturation pressure of 502 kPa. The flow velocities for each pipe section was correspondingly calculated at the average feedwater flowrate. The calculated flow velocities on the suction side was slightly above the allowable value stated in Babcock procedures and technical manuals, but did not pose a risk in terms of vibration excitation.

No unstable behaviour was noted during steady state operation.

- Sudden valve closure would not pose a risk of feedwater flashing, but would likely lead to a dynamic water hammer incident,
- Any sudden valve closure, followed by a valve opening event (regardless of magnitude) had a strong tendency to cause flashing within pump suction lines, causing flow instabilities on the suction side of the pump. Once flow was unstable, this flashing mechanism became self-sustaining. Pump cavitation was also observed during this event,
- Any sudden valve opening event, would lead to feedwater flashing over within individual pump suction lines, which quickly dissipates,

The control philosophy at the time, was scripted in such a fashion as to promote flow instabilities during control valve closure events.
